LEGGATTS CAMPUS
NORTH WATFORD

BAT SURVEY REPORT

Prepared by
ACD Landscape Architects

GEORGE WIMPEY
NORTH THAMES

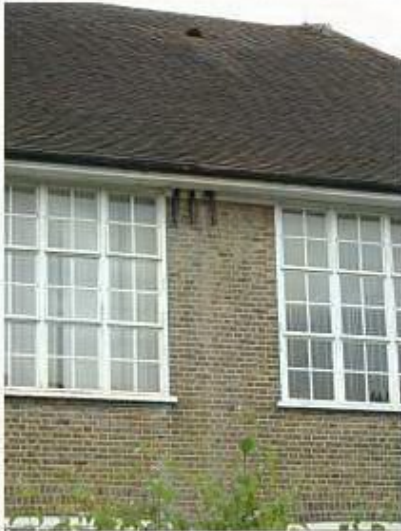
Building No. 1 - Photograph showing building B1 from the eastern courtyard showing gaps around piping in soffit box, which could provide potential access points to bats

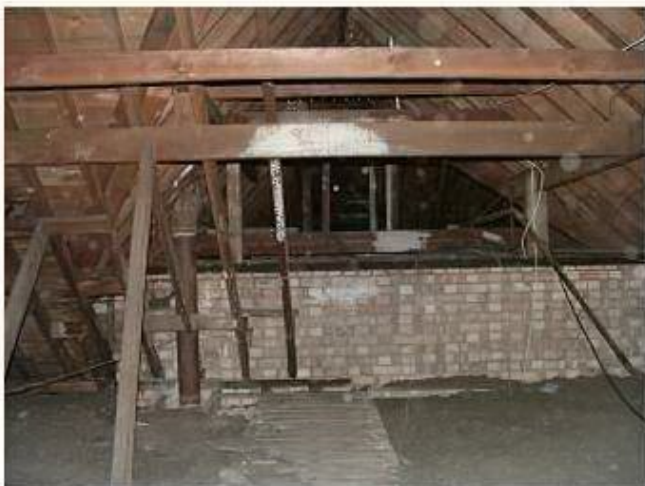
Building No. 1 - Photograph showing loft space on the north side of building B1

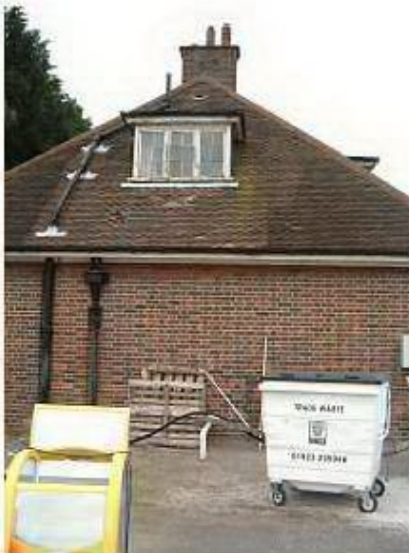
Building No. 7 - Photograph showing building B7 showing gaps between roof tiles, which may afford access to bats

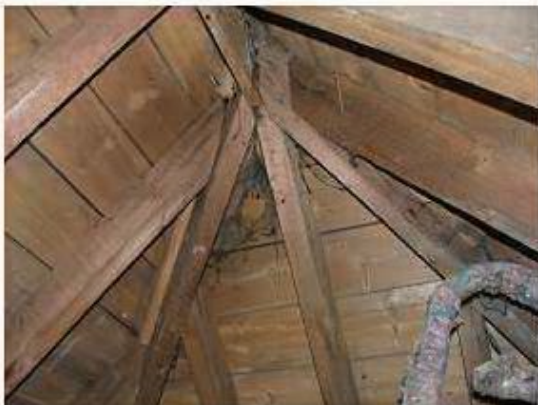
Building No. 7 - Photograph of the small southern section of the loft space of building B7

7	<p>One loft space divided into 2 separate sections by the chimney towards the southern end of this building. The southern section of the loft space was of as similar construction to the north-western corner loft of B4, with a hipped southern wall and a vertical northern wall adjoining the chimney. This section was c. 2.5 m long by 4 m wide by 1.5 m high, and occupied by 2 water tanks (one metal and one plastic). Although light was noted at eave level, numerous cobwebs were noted on the exposed beams and the ventilation tile was provided with wire meshing.</p> <p>The northern section of the loft space could not be directly access but was noted to be c. 8 m long by 4 m wide by 1.5 m high and to include a chimney.</p>
10	<p>One loft space accessed from a 1st floor bedroom. The pitched loft space was noted to be c. 10 m long by 5-6 m wide by 1.2 m high with vertical end walls with under-felt and timber beams.</p> <p>Approximately 200-300 variously aged (including this and last season, i.e. 2007 and 2006) pipistrelle droppings were found clustered on the floor beams at the south-eastern end of the loft directly beneath the ridge beam.</p>

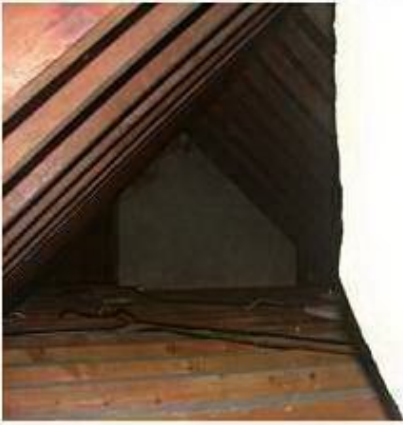
Building No. 7 - Photograph of the larger northern section of the loft space of building B7

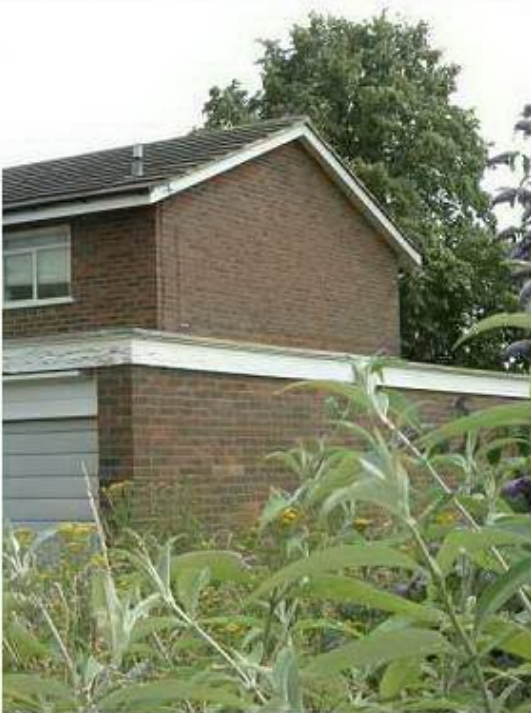
Building No. 10 – Photograph showing the north-western gable end of the building

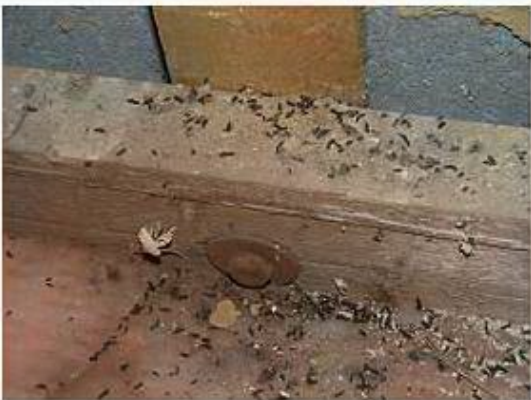
- 2.12 During the internal inspections, evidence of bats was recorded within one (building B10) of the four surveyed buildings. Specifically, a total of approximately 200-300 pipistrelle droppings were found at the south-eastern end of the loft directly beneath the ridge beam.

2.25 The occurrence of c. 200-300 pipistrelle droppings at the south-east end of building B10 is considered to be indicative of a maternity pipistrelle roost. Since no bats were observed to emerge or re-enter during the detector survey work, the estimation of the size of this colony has necessarily been based upon number of droppings alone. Estimation of colony size based on droppings alone is acknowledged to be difficult as it is unlikely that all droppings would be visible and the proportion visible would depend upon how readily the roosting bats can move from the roost through to the inside.

Building No. 10 - Photograph of the pile of pipistrelle droppings at the south-eastern end of B10's loft

2.54 It is, however, considered that a licence would nonetheless be required to undertake the demolition works associated with B10, as these works would necessarily involve the damage and destruction of the identified bat roost.

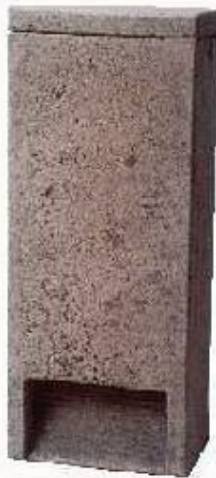
Bat Tube 2FR

- for creation of spaces for large bat colonies
- with integrated access to existing cavities in walls

[Pic. 1]: 2FR system installed (4-units)

This maintenance-free concept enables Bat Tubes to be built into the masonry of a wall.

A number of these Tubes can be placed next to one another in modular form to create much larger spaces with transverse connecting holes. Each Tube has three different types of internal partition.

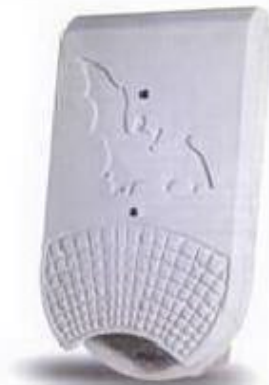
Bat box (Schwegler 1FQ)

This is the latest model from Schwegler and is designed specifically to be fitted on the external wall of a building, including any house or barn. It is designed to be used both as a non-hibernation roost and as a nursery roost and encompasses a special porous coating to help maintain the ideal temperature inside alongside a roughened front panel to allow bats to land securely. Access into the box is via a step-like recess.

Dimensions 56.5cm h x 35cm w x 8.5cm d. It should be noted that this box is designed to be fitted to a wall and would be unsuitable for fences or sheds on account of its weight (15kg).

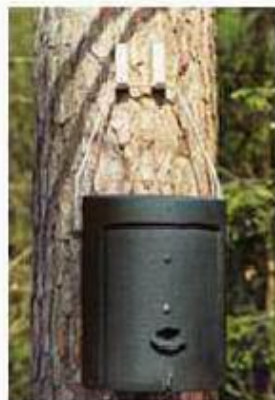
Bat Hibernation Box 1FW (Summer- & Winterquarter for Bat colonies)

This box has the same internal design as the 1FS but its special multi-layered cavity wall provides excellent insulation while also allowing the air to permeate. This makes it ideal both for hibernation in winter and for encouraging large colonies in summer. 180 hibernating individuals have been recorded and this is not at all uncommon. Interior design: There are three internal, grooved, wooden panels which can be easily lifted out for inspection and cleaning, and the same roof panel as the 1FS.

It should be noted that this bat box is heavy and so if mounted above ground should be firmly secured and also sited away from public areas.

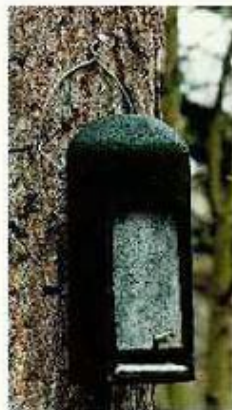
Bat Box 2FN (special)

This model has two entrances, one at the rear against the tree trunk and one at the front. Bats often creep into the rear entrance but leave by the front. It has a domed roof to form clusters and an increased internal height. It is very suitable for woodland species like the Noctule (*Nyctalus noctula*) and has proven highly successful. In one instance 28 Great Bats with nine young was recorded in a 2FN, and this is not uncommon. It is effective against small predators and excludes draughts and light. This model is particularly suitable for use in parks and forests.

Material: SCHWEGLER wood-concrete, galvanised steel hanger

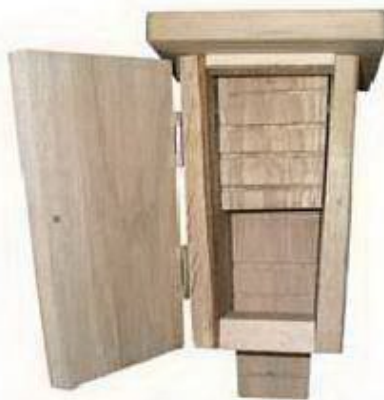
Oak/Larch Double Chambered Bat Box

This wooden box with two internal chambers and access ladder is made from natural sustainable materials and will provide a habitat for many bat species. The heavy construction provides good insulation and longevity, as well as preventing predators from chewing the entrance slot. The front door is hinged for inspection and cleaning.

Wooden boxes should not be painted or treated with any type of preservative, as these can harm the bats. This box can be expected to last 15-20 years.

Dimensions: 300mm h x 135mm w x 135mm d
